Manhole Inspection Summary

Manhole # S45W__038MH

Location Address: **1301 BEASON ST**

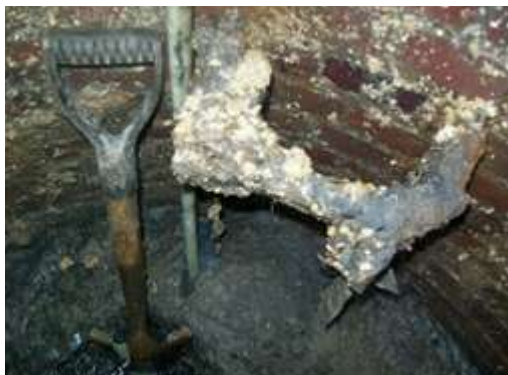
Defect 2

Condition: ☐ Sound ☐ Cracked ☐ Root Intrusion ☐ Deteriorated ☐ Leaks ☒ **Debris**

Count: **6** Missing: **0** ☒ **Corroded**

☒ **Evidence Of Surcharge** Depth: **5** (ft.) ☐ Active Surcharge Present

corroded steps; evidence of surcharge;
bench debris

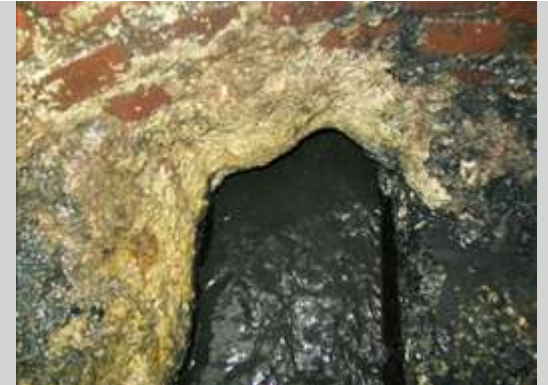
12 O'Clock Outflow

Pipe Height: **10.8** (in.) Rod and Bar (Angled)
Pipe Material: **Clay** ☐ Pipe Lined
Invert Depth: **13.25** (ft.) Flow Characteristics: **Slow**
Deposits: ☐ None ☐ Mud ☐ Sludge ☐ Debris ☒ **Grease**
Silt Depth: **2** (in.) Deposits Extent: **Medium**
Infiltration: **None** Pipe Seal Cond: **Unknown**

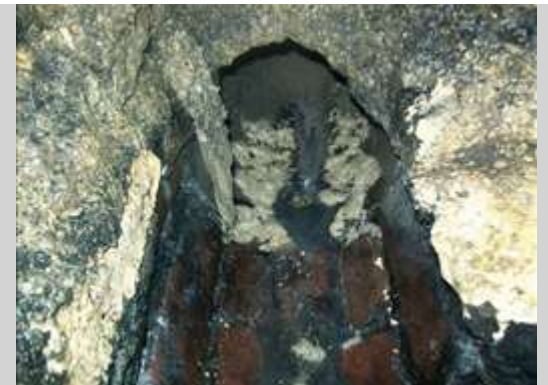
6 O'Clock Inflow

Pipe Height: **8.4** (in.) Rod and Bar (Angled)
Pipe Material: **Clay** ☐ Pipe Lined
Invert Depth: **13.20** (ft.) Flow Characteristics: **Slow**
Deposits: ☐ None ☐ Mud ☐ Sludge ☐ Debris ☒ **Grease**
Silt Depth: **2** (in.) Deposits Extent: **Medium**
Infiltration: **None** Pipe Seal Cond: **Unknown**

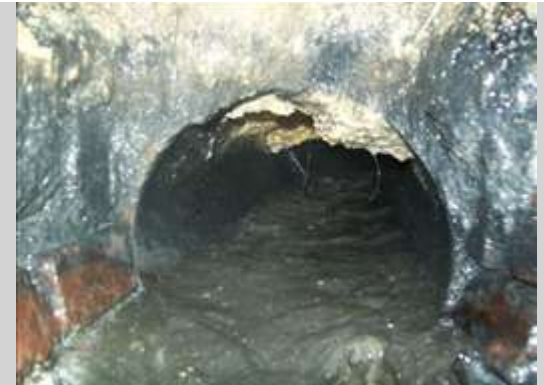
9 O'Clock Inflow

Deposits: ☐ None ☐ Mud ☐ Sludge ☐ Debris ☒ **Grease**

Silt Depth: **2** (in.) Deposits Extent: **Light**
